**FIELD INSPECTION REPORT****STRUCTURE NO. 72-73**  
**INSPECTION DATE: 12/14/05**

# **TUNNEL INSPECTION REPORT**

**ST. ELIZABETHS HOSPITAL – WEST CAMPUS  
WASHINGTON, D.C.  
TUNNEL BETWEEN BUILDINGS 73 & 74**

**FIELD INSPECTION REPORT****STRUCTURE NO. 73-74**  
**INSPECTION DATE: 12/14/05**

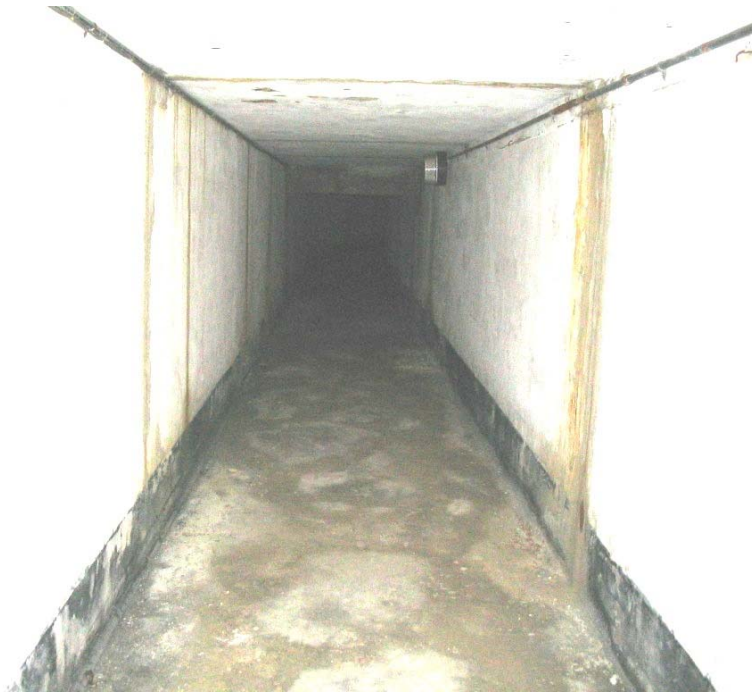
59.1	Minor vertical cracks on walls and transverse cracks on ceiling.
59.3	Undermined area of floor near north end.
402.1,2	Moderate rust on pipes.
402.3	Total section loss on conduit at kink in tunnel (about 140 ft from south end). Minor corrosion along conduits. Old conduits with exposed open junction boxes exist in wall.
402.6	Phone wires are cut.

Photo 4: Vertical Cracking on walls and transverse cracking on ceiling

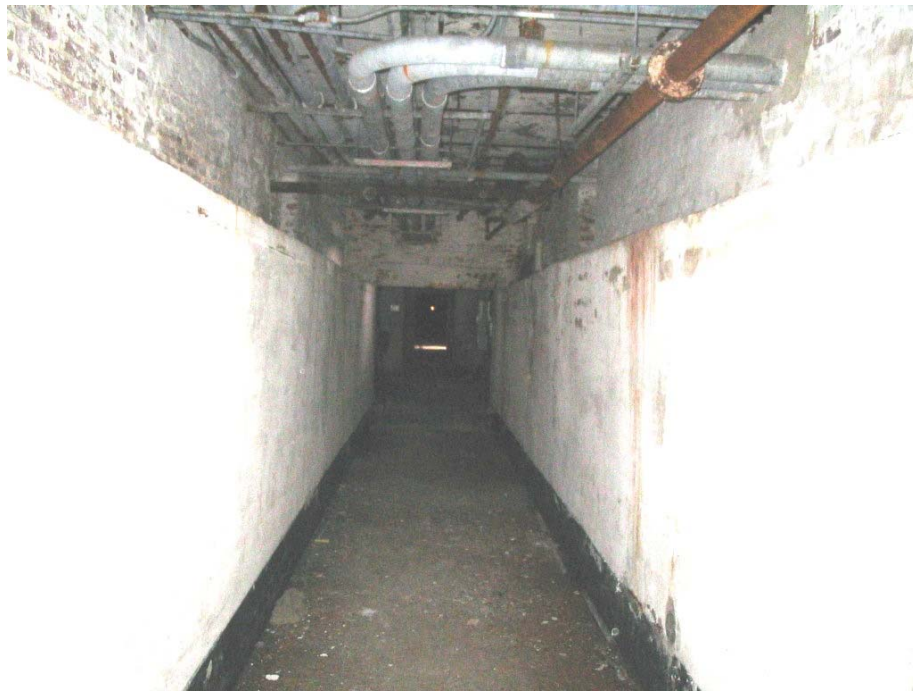
Photo 5: Corrosion on utility pipes

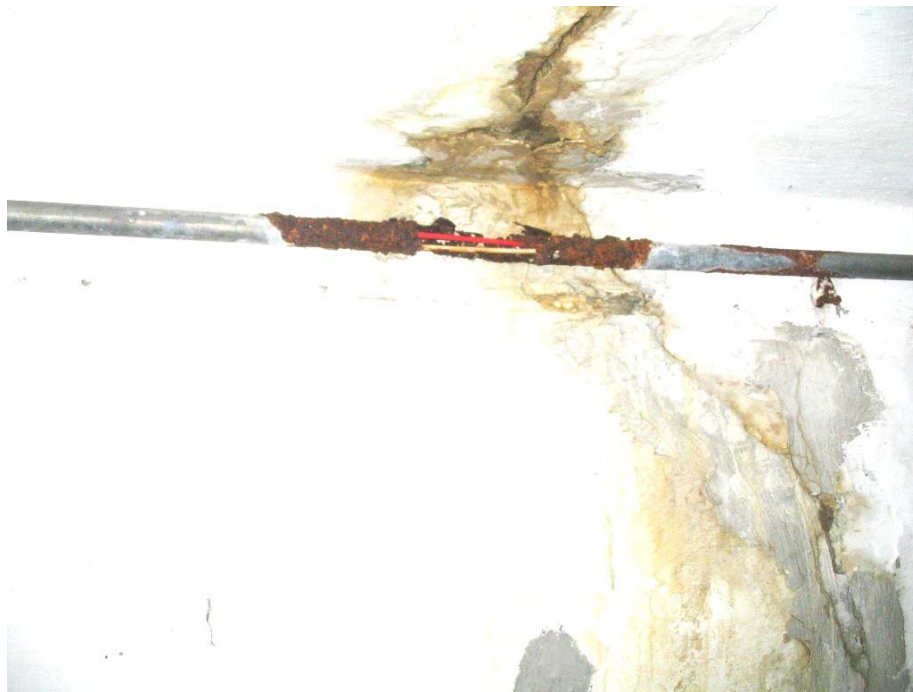
Photo 6: Deteriorated conduit with total section loss; Note exposed wires

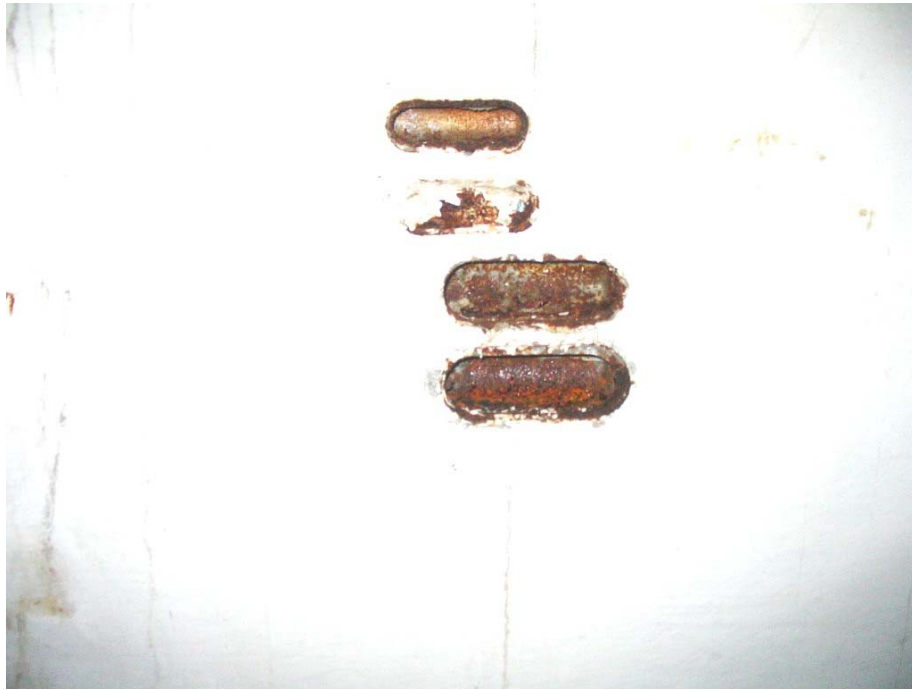
Photo 7: Open junction boxes in wall for old electrical conduits

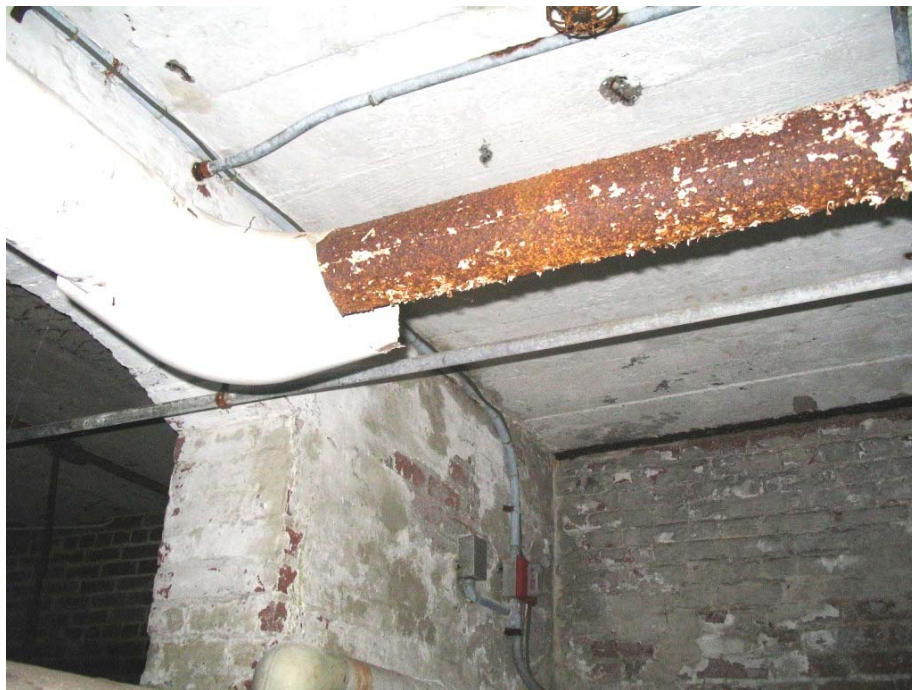
Photo 8: Corrosion on unwrapped portion of pipe

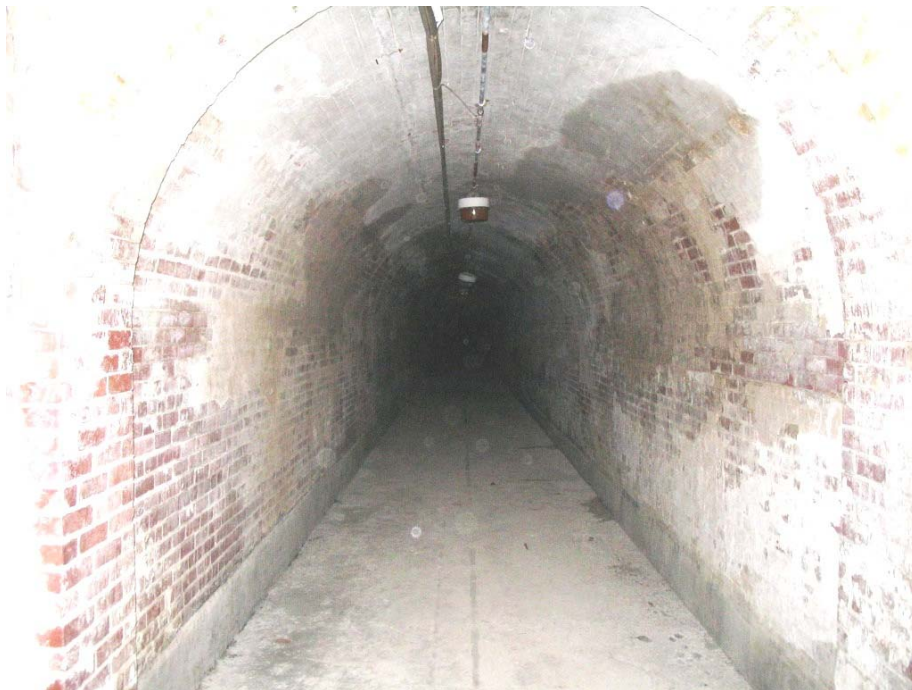
59.1	Several damp areas on brick lining.
402.1,2,3	Moderate to heavy corrosion on steam pipes, water pipes, and electrical conduits. Several light fixtures are damaged.

Photo 4: Looking north toward Building 74; Note damp areas along brick lining

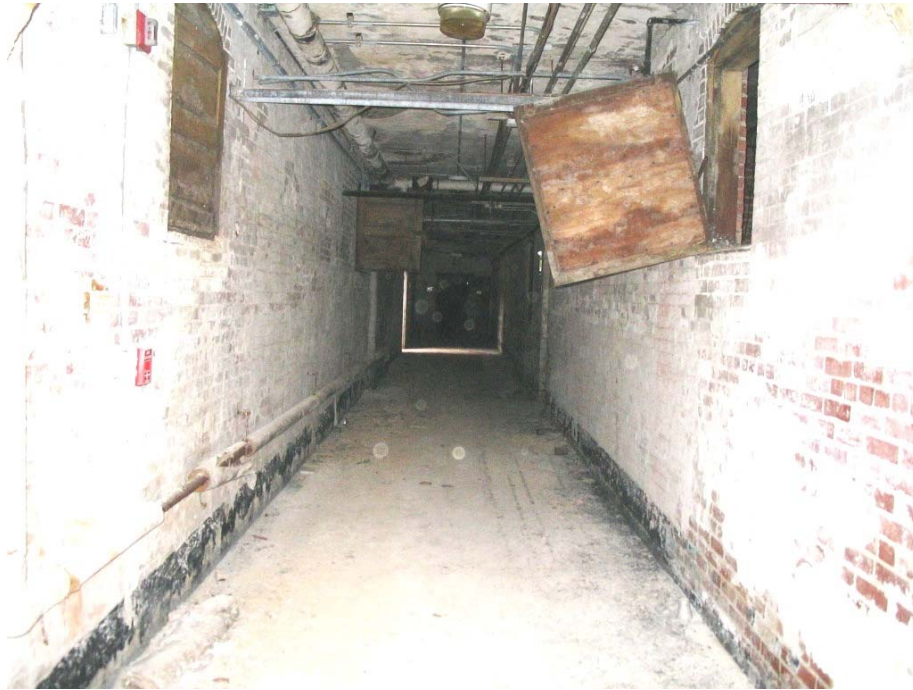
Photo 5: Looking south from south portal; Note hanging door

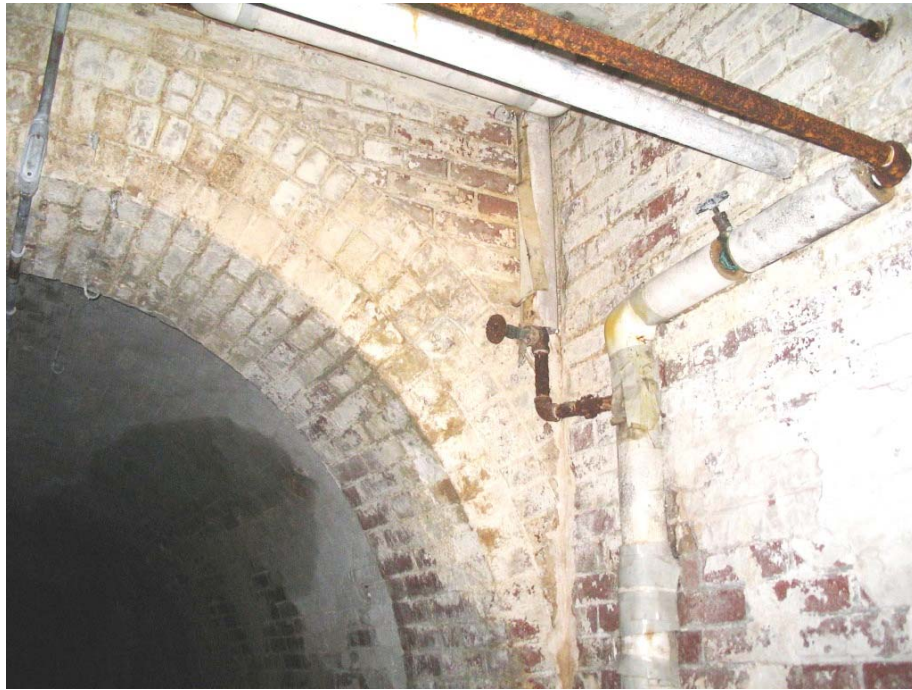
Photo 9: Corrosion on piping at south portal

1. Replace lighting conduits and wiring, 315 LF.
2. Replace electric lines, 315 LF.

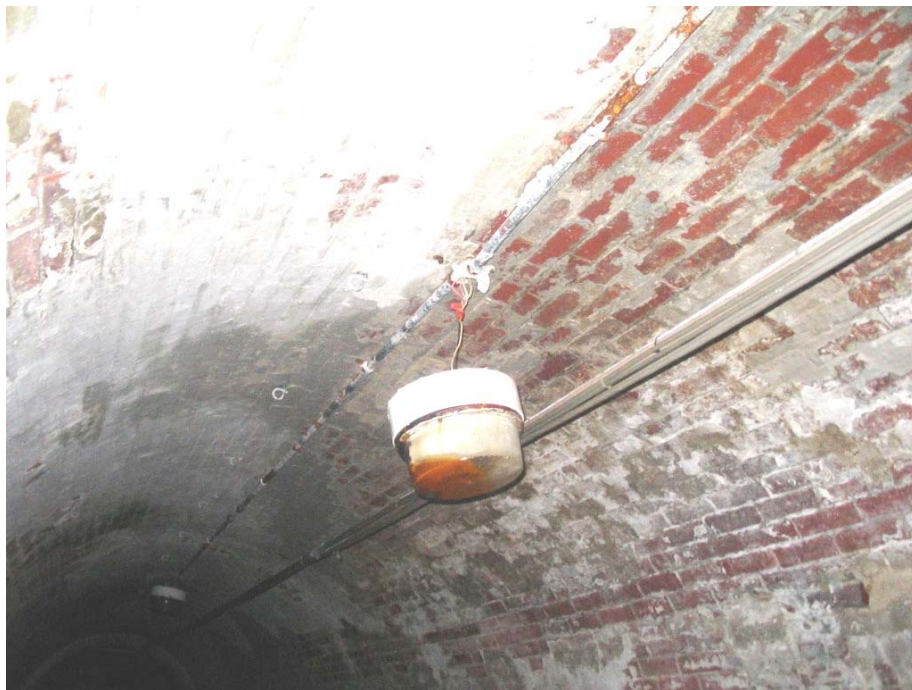
Photo 10: Damaged light fixture; Note corrosion on conduit

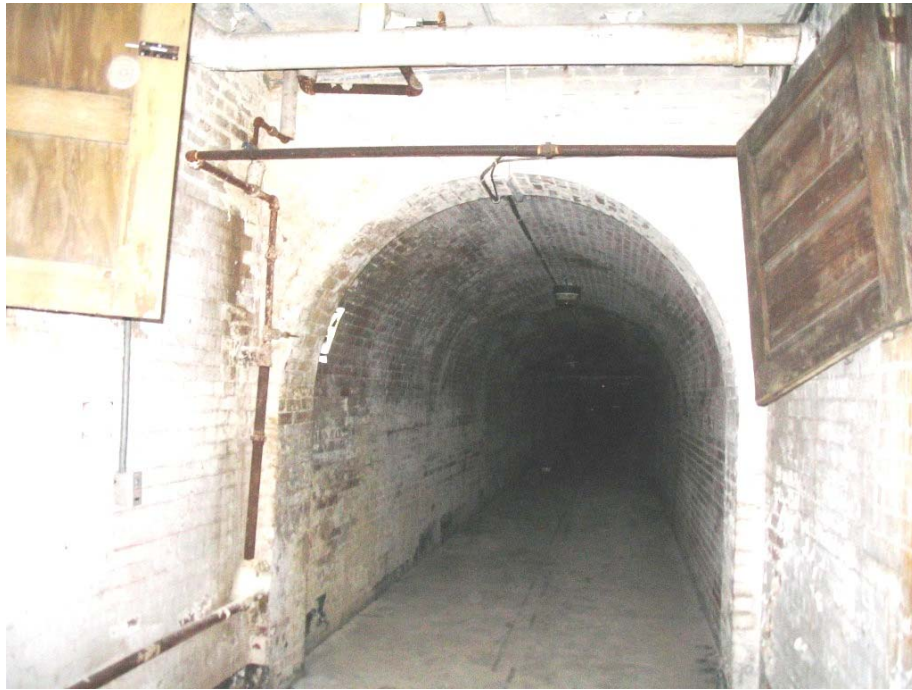
402.2	Minor corrosion of water pipes.
402.3	Lighting conduits have minor to moderate corrosion and are hanging and laying on floor in areas.

Photo 3: Looking south toward Building 74; Note corrosion on pipes

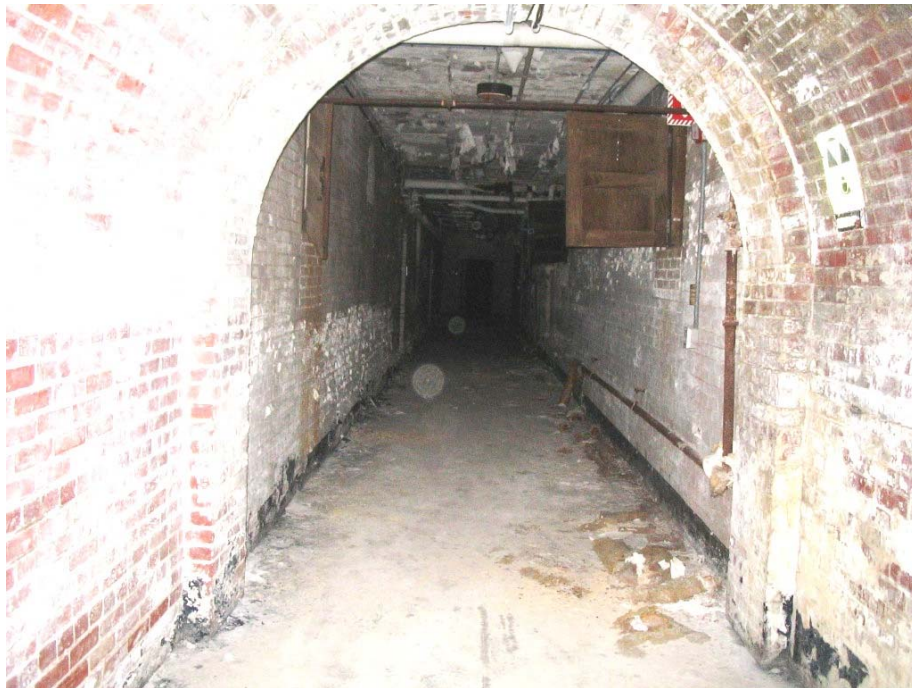
Photo 4: Looking north toward Building 75; Note corrosion on pipes

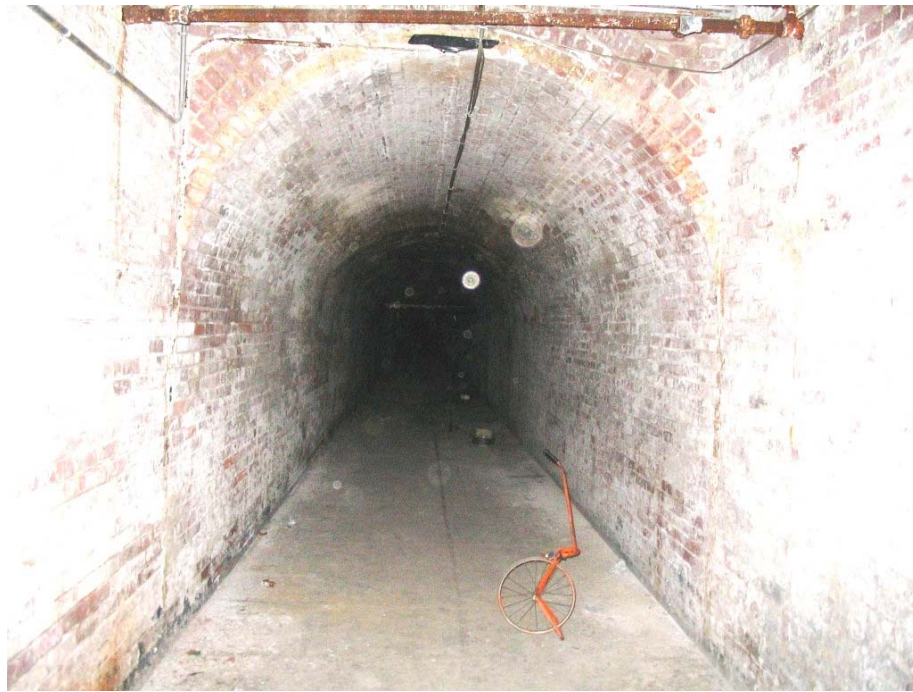
Photo 5: Looking north toward Building 75; Note corrosion on pipes

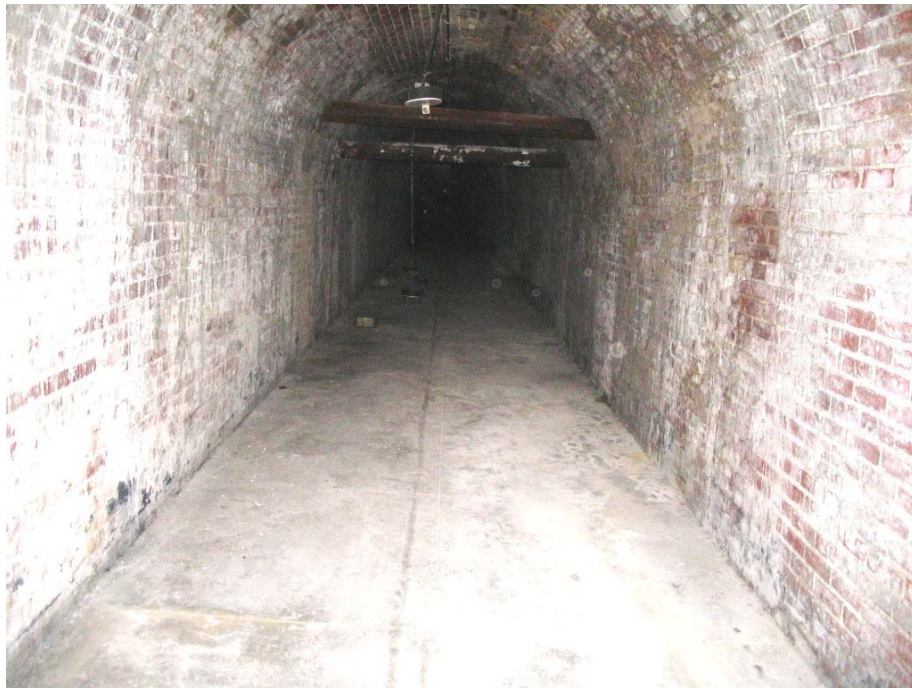
Photo 10: Looking south toward Building 74; Note downed lighting conduit and reduced vertical clearance due to pipes

1. Replace lighting conduit and wiring, 300 LF.

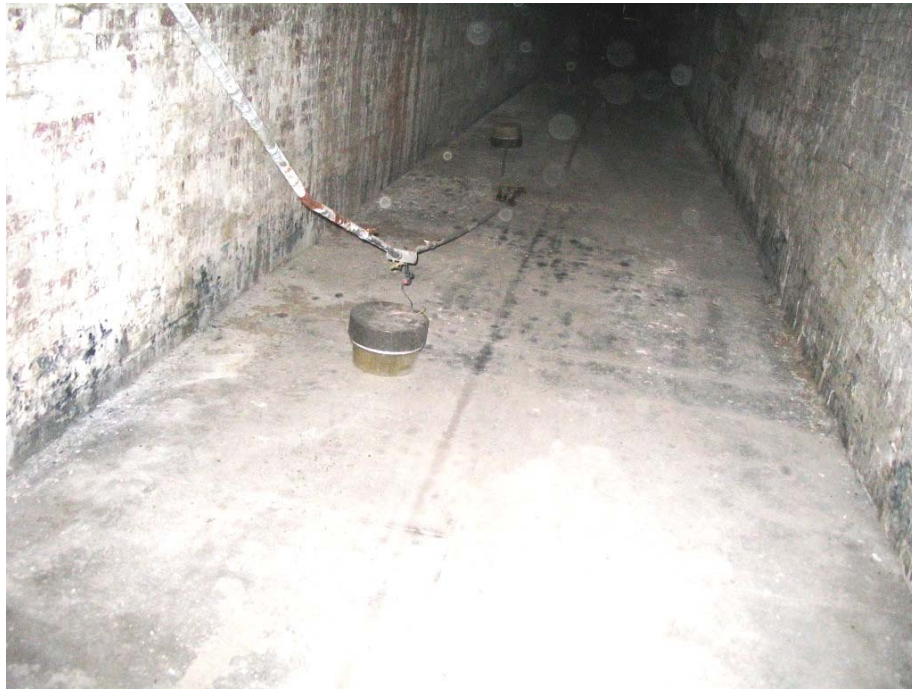
Photo 11: Downed light and conduit

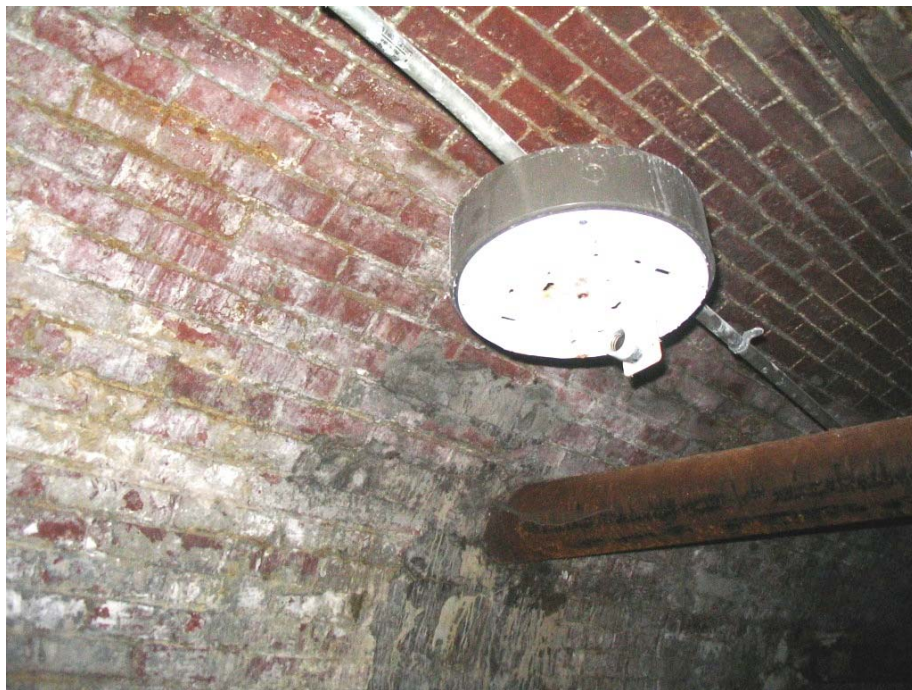
Photo 12: Damaged light fixture
